Crash Tests

TOYOTA HILUX UTILITY (2WD)

September 2001 on No airbags

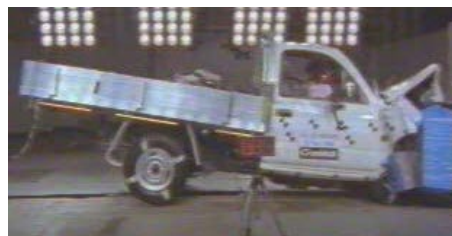
Offset crash test at 64km/h

The passenger compartment held its shape reasonably well in the offset crash test. The front part of the driver's floor was pushed rearwards 195mm. The brake pedal moved rearwards by 93mm and upwards 15mm. The dash moved 37mm towards the driver. The steering wheel hub moved upwards 64mm and sideways 101mm. There was no rearwards movement. The front ("A") pillar moved 86mm rearwards. The roof buckled upwards above the driver and the width of the driver's doorway shortened by 53mm. Both doors remained closed during the crash. After the crash high manual effort was required to open the driver's door. The driver's head hit the hub of the steering wheel with hard contact and protection from serious injury was poor. Driver neck tension was also poor. The driver's knees hit the dash, steering column and park brake lever. The passenger's knees hit the glove box and dash.
