Crash Tests

New Car Safety

Daewoo Leganza

1998-on

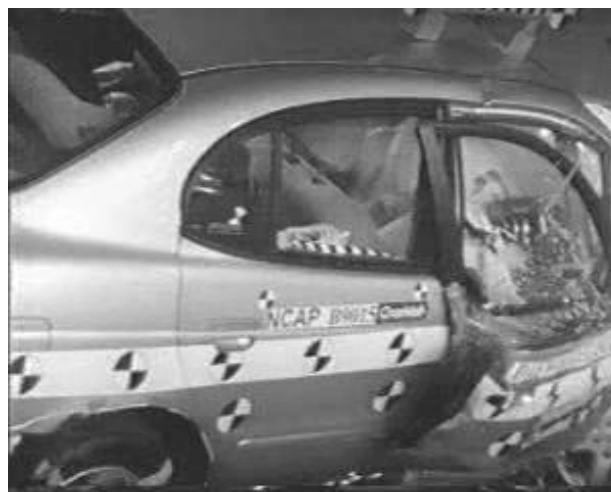
Offset crash test at 64km/h

The passenger compartment was substantially deformed in the offset crash test. The front part of the driver's floor was pushed rearwards 36cm and was severely folded. The brake pedal moved rearwards by 37cm, ending up within 12cm of the seat. The dash moved 24cm towards the driver. The roof buckled upwards above the driver and the width of the driver's doorway shortened by 19cm. All doors remained closed during the crash. After the crash tools were required to open the driver's door.

The airbag cushioned the head of the driver but the head then started to twist and rolled off the side of the airbag. The driver's knee hit a stiff metal bracket and tube behind

the dash. The passenger's head hit the dash with a severe impact. The passenger's knees hit the glove box and dash.
