Crash Tests

New Car Safety

DAEWOO NUBIRA

1999 on

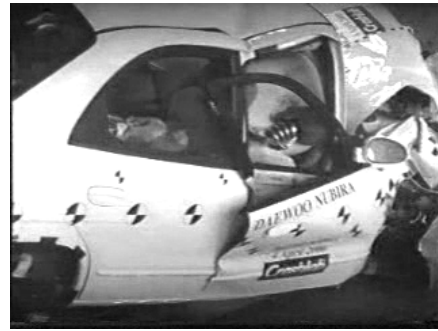
Offset crash test at 64km/h

The DAEWOO NUBIRA did not perform well in the offset crash test (score 4.73 out of 16). The passenger compartment was substantially deformed. The driver's contact with the airbag was unstable. Protection from serious leg injury was poor for the driver. The vehicle performed better in the side impact crash (score 8.37 out of 16) but there was a high risk of life threatening chest injury for the driver.

The passenger compartment was substantially deformed in the offset crash test. The brake pedal moved rearwards by 25cm. The dash moved 18cm towards the driver. The roof buckled upwards above the driver and the width of the driver's doorway shortened by 20cm. All doors remained closed during the crash. After the crash all doors could be opened without tools. The exhaust pipe pushed against and dented the fuel tank. The tank did not rupture but this could be a fire hazard.

The steering column moved left and this affected airbag positioning. The airbag cushioned the head of the driver but the head then started to twist and rolled off the side of the airbag. The head then hit the front pillar. During rebound the head hit the top of the doorframe. The impact of the driver's knees against the dash was cushioned by foam but the forces were still high enough to give a moderate risk of injury. There was also a risk of knee injury from a sharp metal bracket near the centre console.
