Crash Tests

HOLDEN BARINA CITY

2001 on

Overall Evaluation

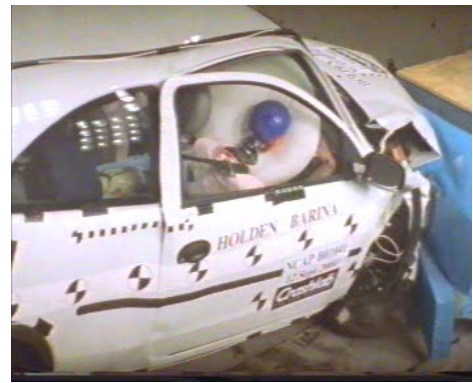
Offset crash test at 64km/h

The passenger compartment held its shape well in the offset crash test. The front part of the driver's floor was pushed rearwards just 63mm. The brake pedal moved rearwards by 107mm. There was minimal dash movement. The steering wheel hub moved rearwards 23mm, upwards 66mm and sideways 8mm. The front ("A") pillar moved 52mm rearwards. The width of the driver's doorway shortened by 47mm. All doors remained closed during the crash. After the crash a crow bar was required to open the driver's door.

The airbag cushioned the head of the driver but the head then rolled off the side of the airbag and contact was unstable. The driver's knee hit the steering column shroud and dash. The shroud has a light metal plate and foam padding on the inside and these adequately protected the knees from the ignition switch barrel. The passenger's head was cushioned by the airbag. The passenger's knees hit the glove box and dash.
