# Crash Tests

### TOYOTA KLUGER GRANDE

2003 on Front+side & head airbags

#### OCCUPANT PROTECTION: 4 Stars

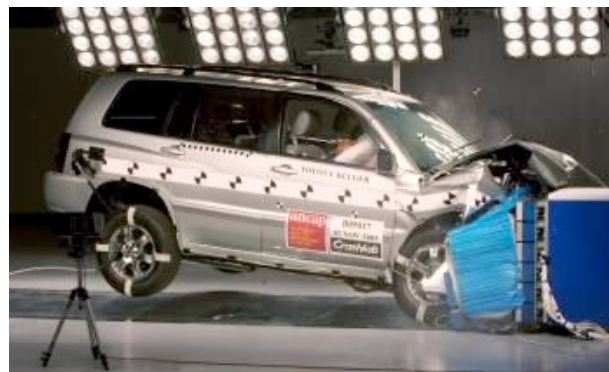
Offset test at 64km/h

The Toyota Kluger Grande scored 10.43 out of 16 in the offset crash test. The passenger compartment held its shape well. Protection from serious chest and leg injury was marginal for the driver.

The passenger compartment held its shape well in the offset crash test. The brake pedal moved rearwards by 106 mm and downwards 23mm. The steering wheel hub moved rearwards 18 mm, upwards 52 mm and sideways 29 mm. The front ("A") pillar moved 15 mm rearwards. All doors remained closed during the crash. After the crash moderate manual effort was required to open the driver's door.

The airbag cushioned the head of the driver and contact was stable. Steering column components were a potential source of injury for the driver's knees. The passenger's head was cushioned by the airbag. The passenger's knees hit the glove box and dash.
